M&D Milestone NO.*48(51)
Counties (MD/PA) Baltimore/York

A COMPARATIVE ASSESSMENT OF THE STATUS AND CONDITION
OF THE MONUMENTS ON THE MASON AND DIXON LINE.

DATE OF OBSERVATION: 18 FEB 88

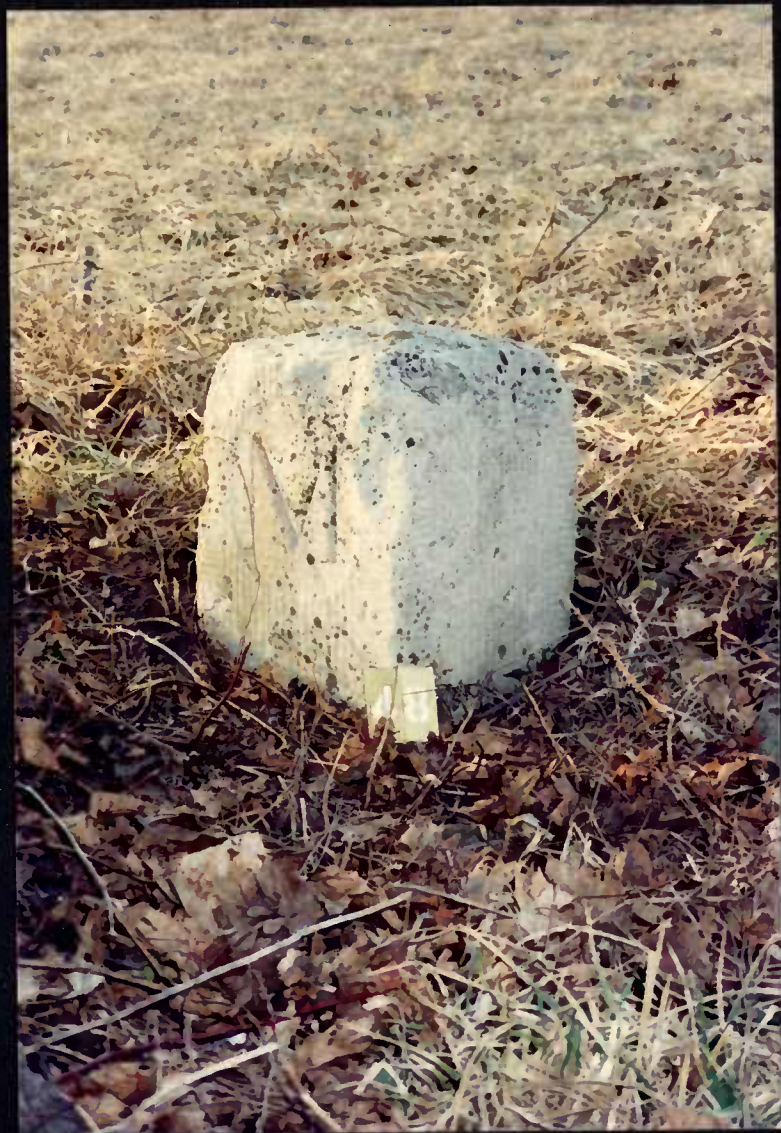
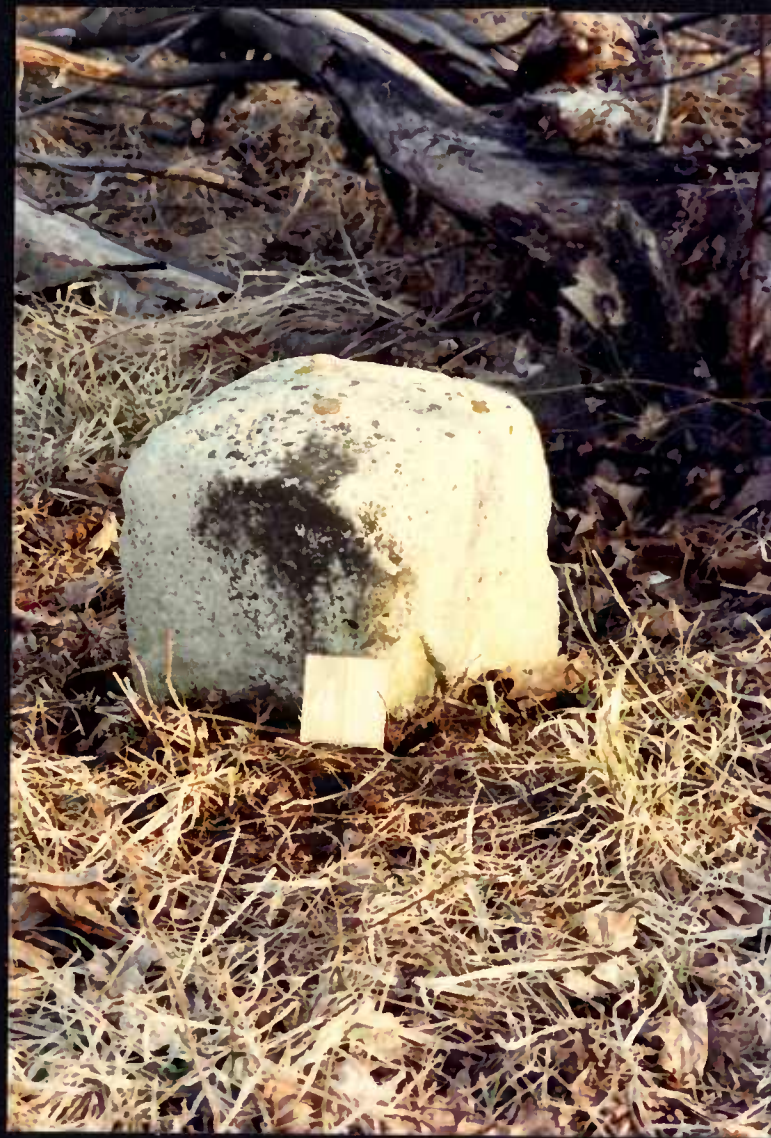
PHOTO Nos.: 48(51) A,B,C.

DESCRIPTION/MEASUREMENTS: The stone is 15" out of ground on the SE corner and about 9" out on the NW corner. "P" is worn severely but "M" is good. The stone appears to be heaved slightly to the south and east.

Current status and condition: The secluded location affords protection but the stone appears to be endangered by its proximity to a large tree. The general condition of the stone is good, but at the time of observation there was some indication that the foundation was deteriorating since the stone has a slight lean southward.

NOTES: Top edges are well rounded with large chips at NW and SE corners. Vertical edges show slight chipping. Fluting is evident on East and South faces.

#48(51)
18 FEB 88
Status: Protected to Endangered.
Condition: Good to Deteriorated.
Foundation: Stone leans southward.
Foundation is disturbed.

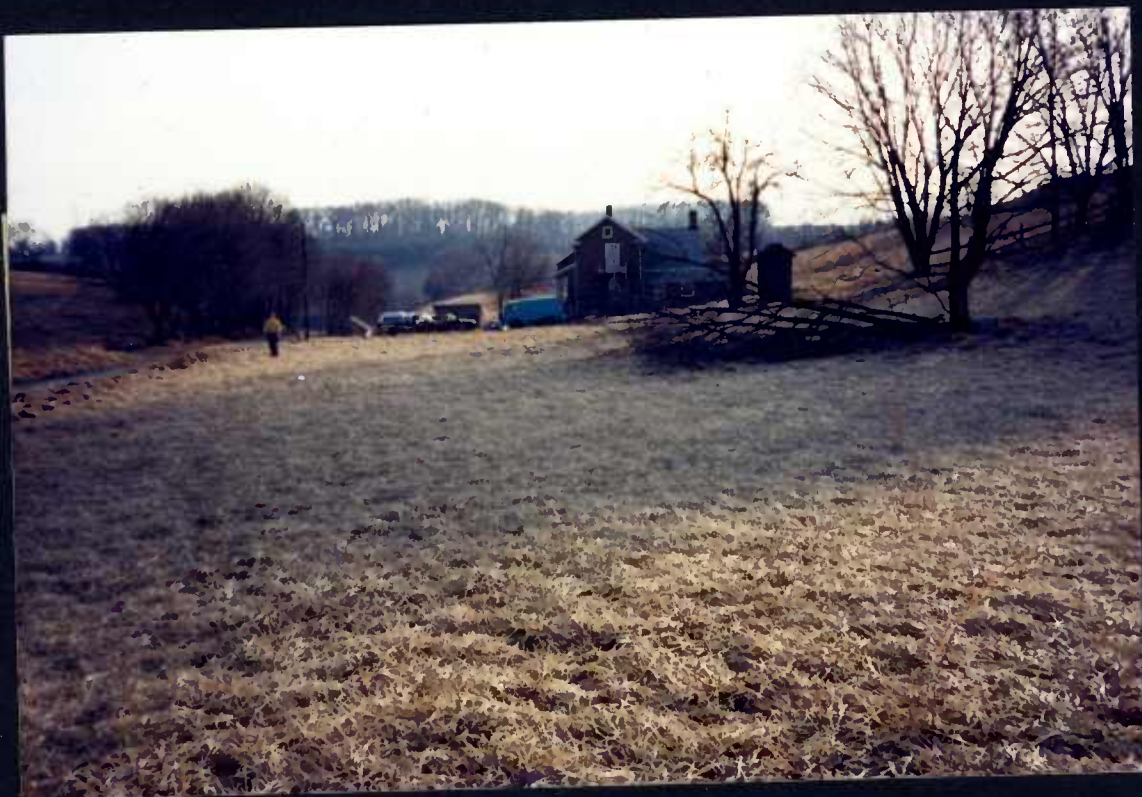
#48(51)
General site view looking south.
